Your survey report

Alexander Heron Surveyors

Level 2

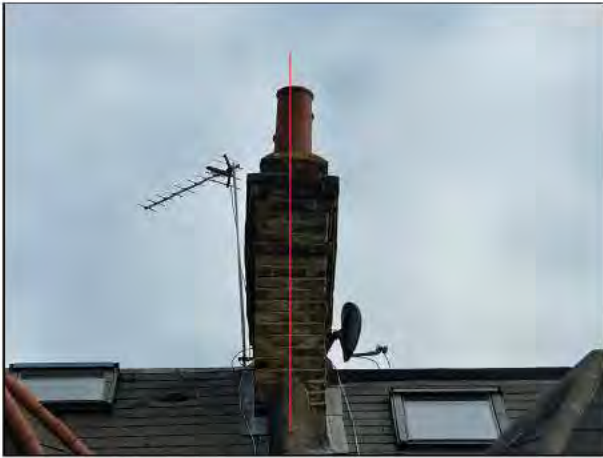
4 - Leaning stack

The chimney stack appears to be leaning. The current degree of lean appears to be within the acceptable tolerances. This is often as a result of sulphate attack caused by the burning of fuels. Hygroscopic salts form and collect in the mortar between the bricks. The salts attract moisture and when the salts dry out they crystallise within the mortar and expand. Due to the prevailing weather in this country generally coming from one direction, one side of the stack will be more effected than the other. As the salts expand the width of the joint expands with it creating the lean. Condition rating 2

Whilst there is no current requirement for repairs, you should ensure you periodically check the chimney stack and if you notice it leaning in the future you should instruct a qualified contractor to provide you with advice on the options for repair.

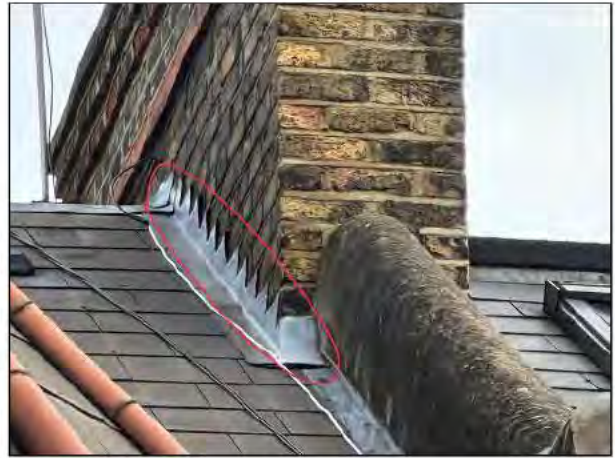
5 - Flashing

The flashing is not properly installed. The defective flashing will not adequately protect the abutment from rain water. If rainwater is able to penetrate the gap, it can cause significant moisture related issues to the structure below. Condition rating 2

You should instruct a reputable contractor experienced in high-level works to quote for repairs to the defects identified in order to ensure you are aware of the potential costs prior to committing to exchanging contracts.

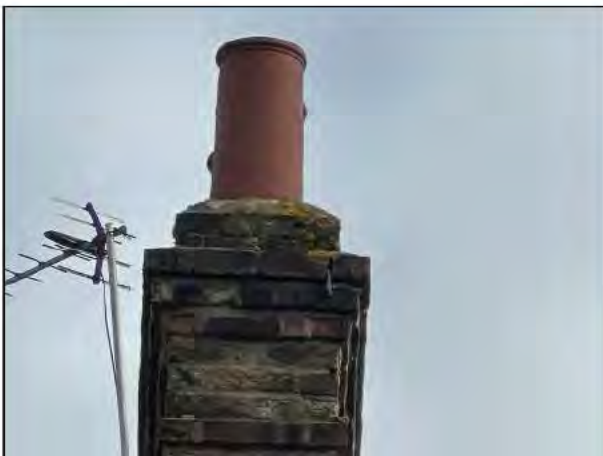
6 - Flashing and pots

Where seen, all of the chimney pots are uncapped. Uncapped chimney pots are susceptible to water ingress and are attractive to animals who can use them as a nesting location. To prevent these problems, an appropriate guard should be installed. Condition rating 2

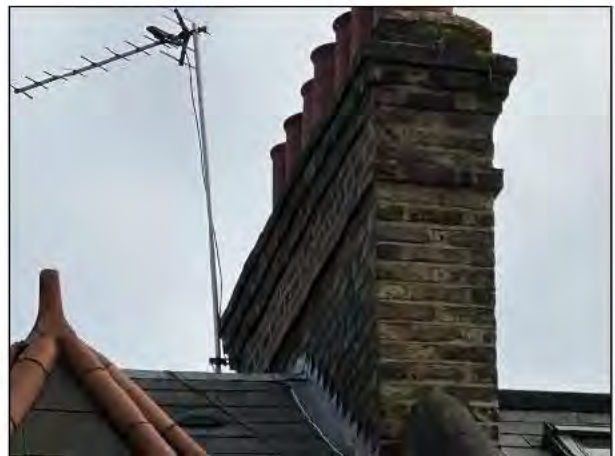
7 - Masonry

Cracks are present within the stack masonry. The cracks identified are believed to be as a result of historic movement to the property and are common in a building of this age. There is no evidence to suggest that there is any ongoing issues of movement. Condition rating 2

The brickwork has spalled and the mortar joints have become loose and started to deteriorate. This leaves the stacks at risk of accelerated deterioration as they are now more susceptible to water ingress. Condition rating 2

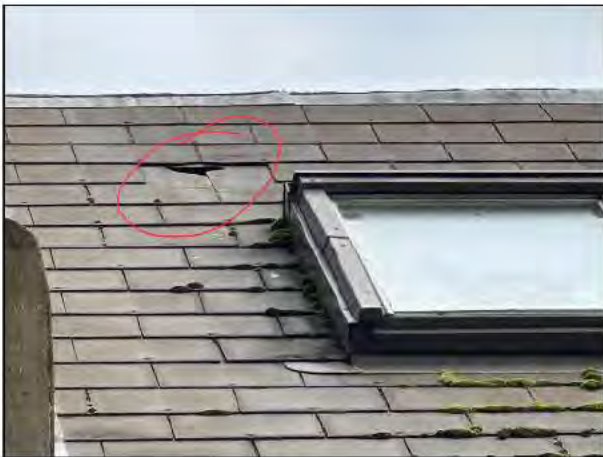
9 - Damaged coverings

There are a number of damaged slates and the roof is no longer adequately protected from the elements. The roof covering provides protection from the weather to the supporting structure beneath. Where the covering becomes defective, the structure is at more risk of coming in to contact with water which can lead to moisture related issues internally. Condition rating 3

You should instruct a reputable contractor experienced in high-level works to quote for repairs to the defects identified in order to ensure you are aware of the potential costs prior to committing to exchanging contracts.

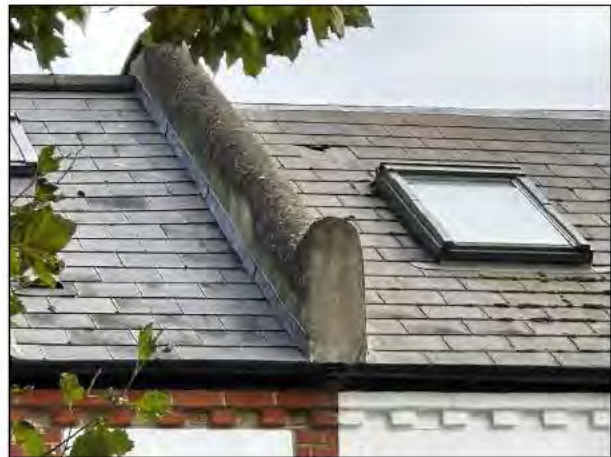
10 - Parapet

The render to the parapet walls is damaged. The rendered covering is likely to be a cement type that is unsuitable for the type of building. The parapet walls are now at greater risk of deterioration from water ingress which may also penetrate to the inside of the property. Condition rating 2

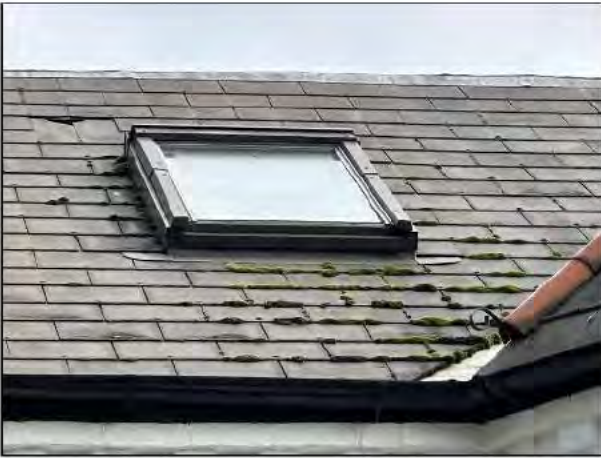
11 - Vegetation to the covering

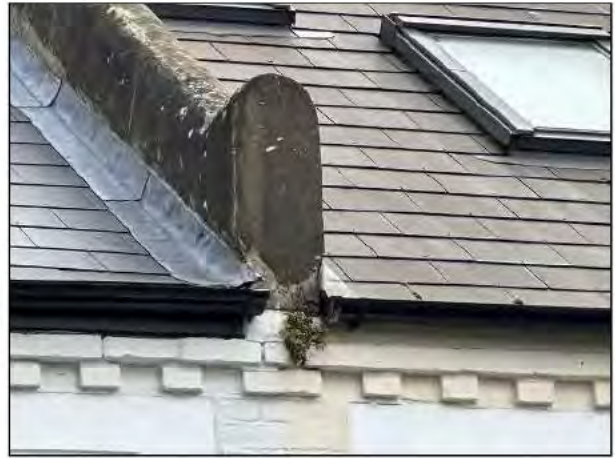
12 - Close up of vegetation and render damage

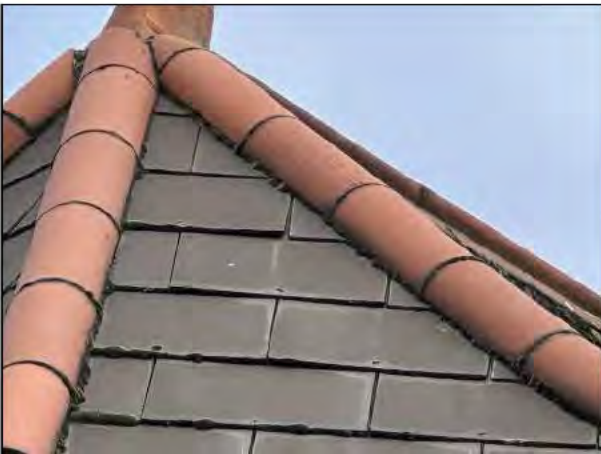
13 - Example of the lifting slates

A small selection of the coverings are suffering from a subtle amount of lifting. This happens after installation and mainly affects coverings made from synthetic material. If the defect progresses further the roof may become more susceptible to penetration from driven rain. This can also lead to loosening of the fixings which can lead to the coverings becoming dislodged and slipping. The current degree only appears to affect the appearance and there is no evidence to suggest it is affecting the overall performance of the element. Condition rating 1 A small amount of vegetation is present to the covering and parapet. The presence of vegetation builds up over time and, if left, it can accelerate the deterioration of the affected areas. It should be periodically removed to prolong the lifespan of the roof. Condition rating 1

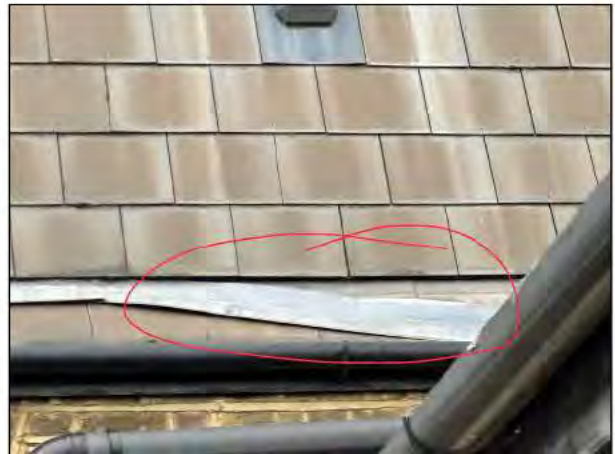
The weatherproofing to the rear dormer is loose. Inadequate water proofing at the junction makes the area more susceptible to water penetration. This can lead to damp issues internally. Condition rating 2

14 - Dormer flashing defective

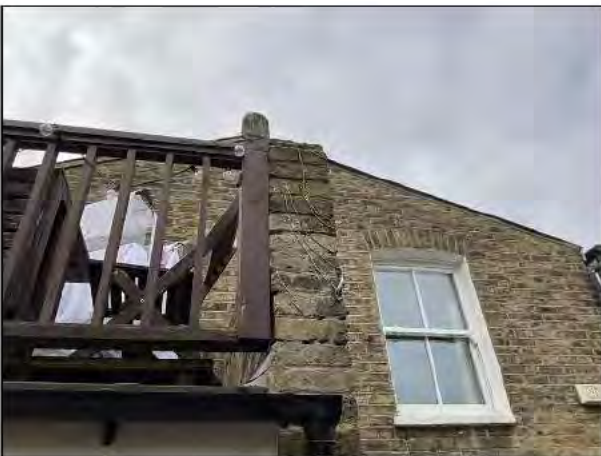
15 - Rear parapet

The masonry to the parapet wall at the rear is deteriorating. The mortar is loose and damaged and bricks are missing. The wall is at risk of further accelerated deterioration due to its condition as rainwater can become trapped within the gaps of the damaged areas. There is also an increased risk of water penetration presenting internally in the future. Condition rating 2

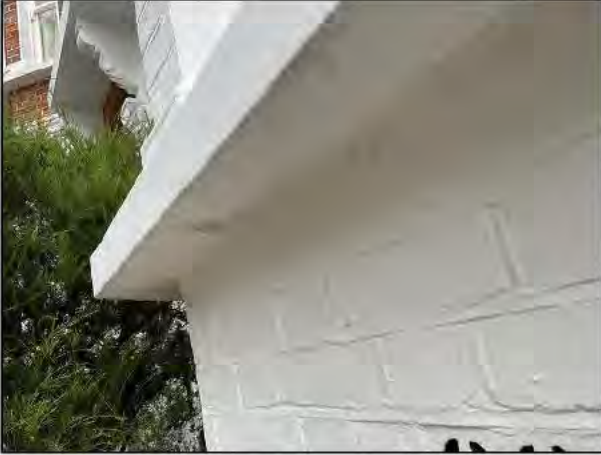
22 - No drip grooves

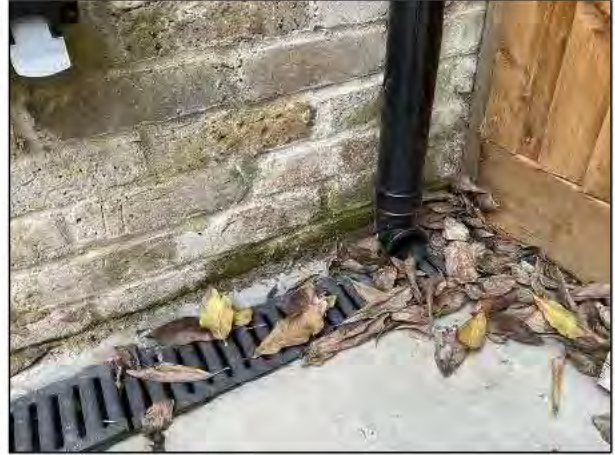
23 - Algae

There is algae growth on the external wall that is likely to be being caused by continued exposure to high-levels of moisture. This appears to be due to splash back from the downpipe and as a result of the defective guttering to the neighbours extension. This defect may also be contributing to the dampness identified inside the property. Whilst the defect remains, the masonry in this area may deteriorate faster than the surrounding masonry. Condition rating 2

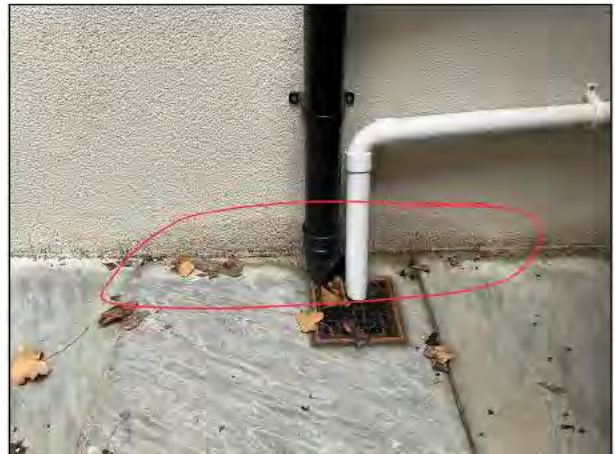
25 - Render in contact with the ground

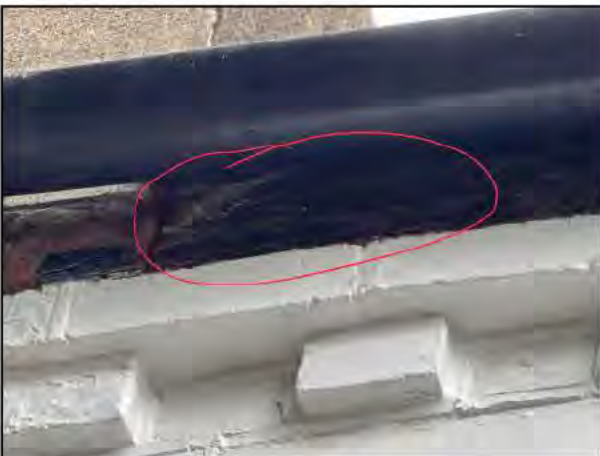
32 - Exposed timber

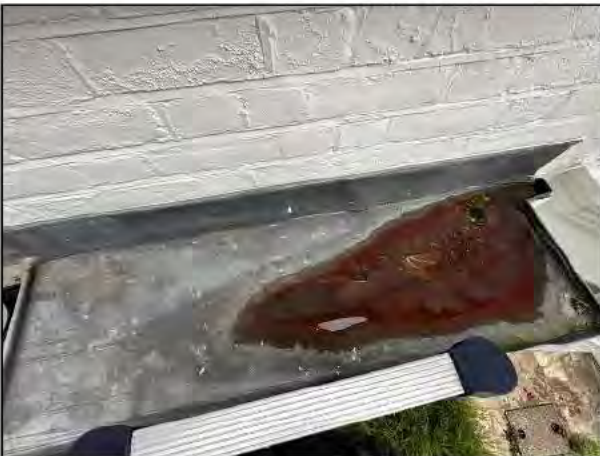
34 - Ponding

The rainwater does not effectively drain from the surface of the roof. As a result there is ponding (where water collects on the roof without draining away) present. This can reduce the life of the covering as prolonged exposure to water is likely to accelerate deterioration. Condition rating 2

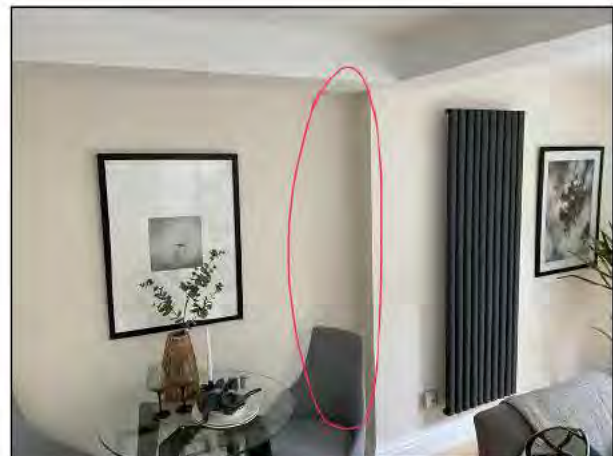
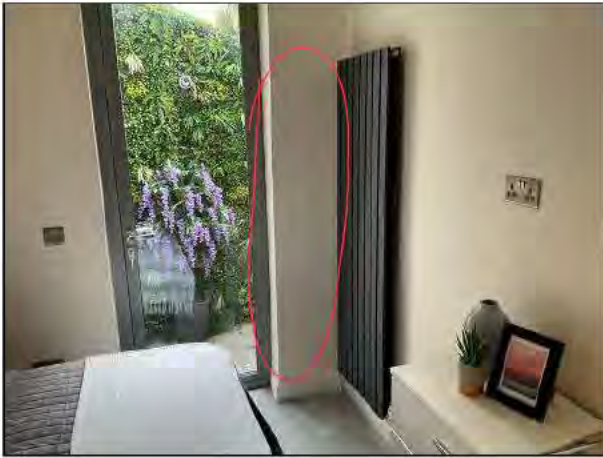
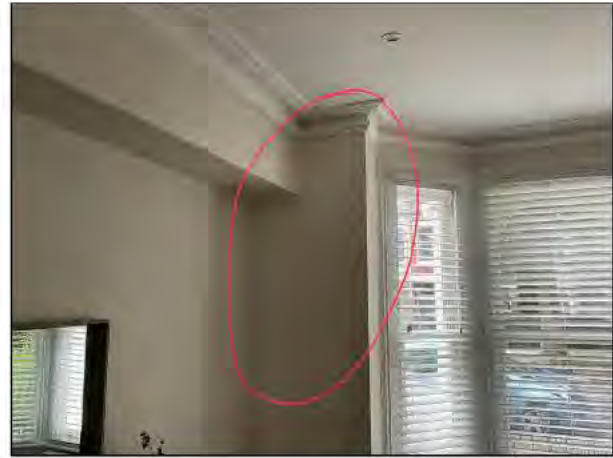
46 - Example of area where dampness was detected

47 - Example of area where dampness was detected

48 - Example of area where dampness was detected

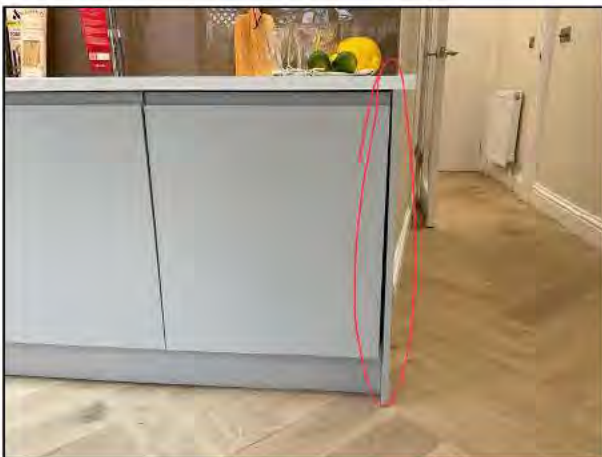
51 - End panel not level

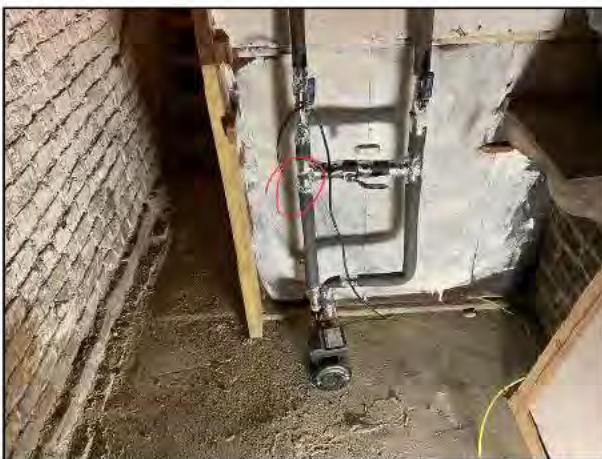
60 - Pump not connected

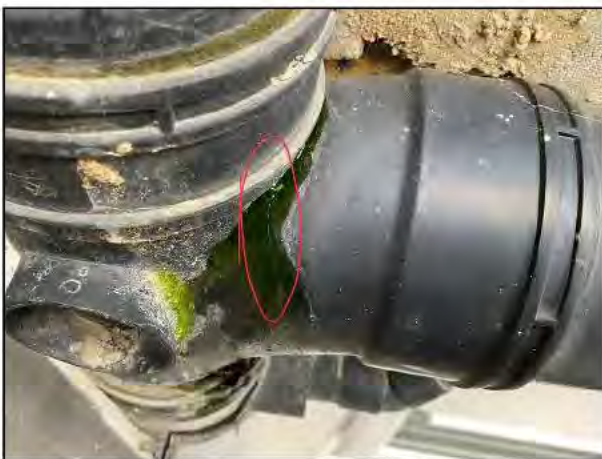
66 - Cracked soil pipe

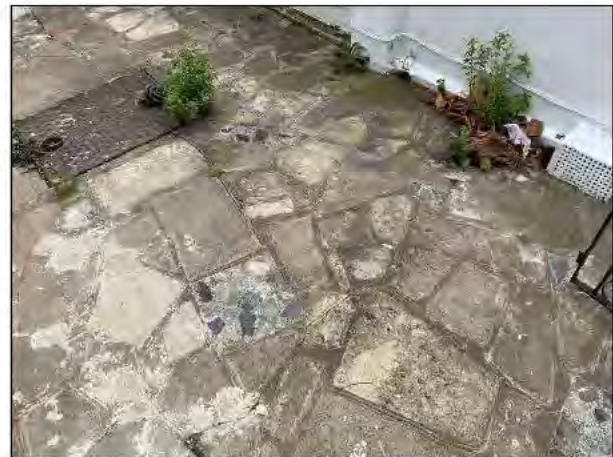
37 - Example of the damaged paving

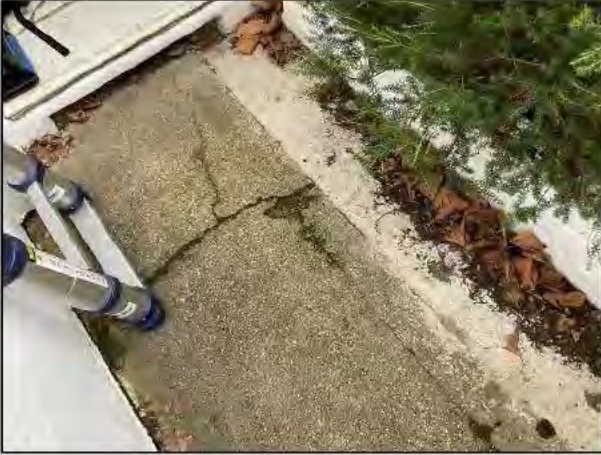
38 - Cracked path
