Your survey report

Alexander Heron Surveyors

Level 2

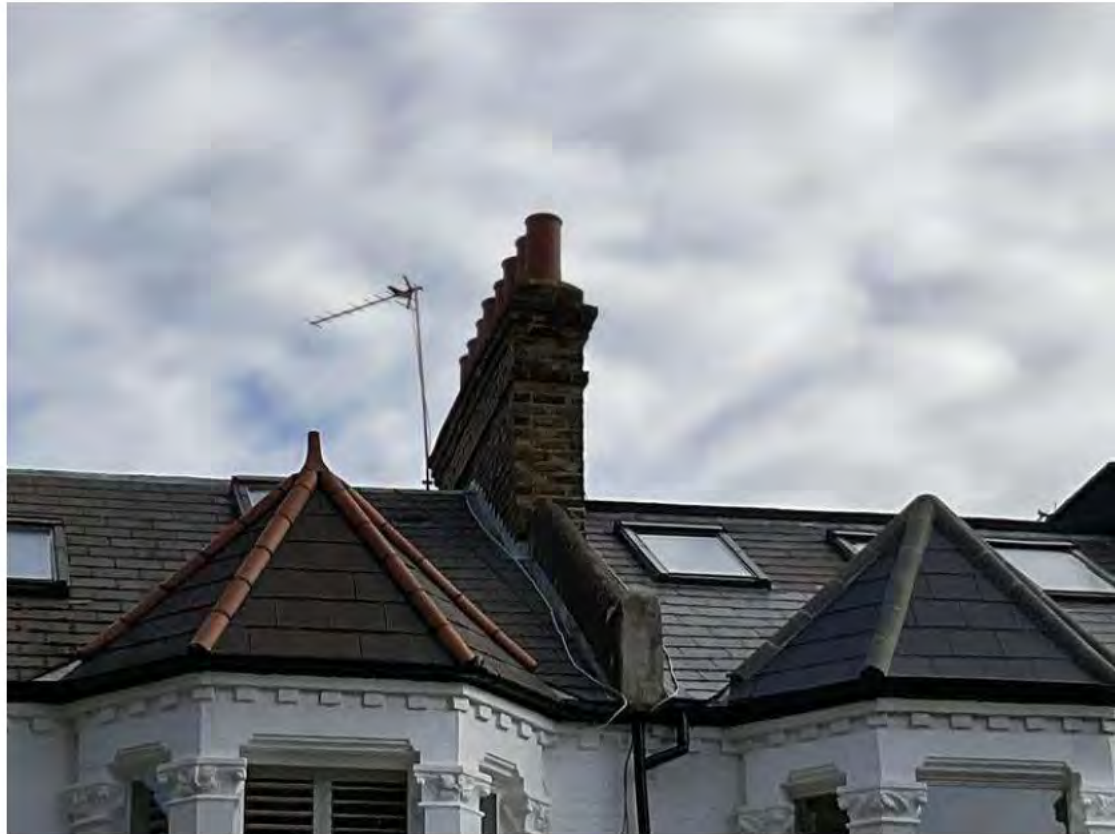
4.1 CHIMNEY STACKS

The chimney stack appears to be leaning. The current degree of lean appears to be within the acceptable tolerances. This is often as a result of sulphate attack caused by the burning of fuels. Hygroscopic salts form and collect in the mortar between the bricks. The salts attract moisture and when the salts dry out they crystallise within the mortar and expand. Due to the prevailing weather in this country generally coming from one direction, one side of the stack will be more effected than the other. As the salts expand the width of the joint expands with it creating the lean. Condition rating 2

The flashing is not properly installed. The defective flashing will not adequately protect the abutment from rain water. If rainwater is able to penetrate the gap, it can cause significant moisture related issues to the structure below. Condition rating 2

The waterproof layer at the top of the stack does not appear to be watertight, I was able to see that the element is cracked. This can lead to damp penetration within the roof void below. Condition rating 2

Cracks are present within the stack masonry. The cracks identified are believed to be as a result of historic movement to the property and are common in a building of this age. There is no evidence to suggest that there is any ongoing issues of movement. Condition rating 2

The brickwork has spalled and the mortar joints have become loose and started to deteriorate. This leaves the stacks at risk of accelerated deterioration as they are now more susceptible to water ingress. Condition rating 2

Where seen, all of the chimney pots are uncapped. Uncapped chimney pots are susceptible to water ingress and are attractive to animals who can use them as a nesting location. To prevent these problems, an appropriate guard should be installed. Condition rating 2

A large amount of vegetation build up (including lichen, moss and algae) is present to the brickwork and flashing. The presence can accelerate deterioration and over time, the growth will cause damage to the element by loosening the cement covering. Condition rating 2

To repair the chimney safely and avoid damaging the roof covering, contractors will have to use appropriate access equipment for high-level building work and this can be expensive. The work should be undertaken in conjunction with other high-level repairs to minimise future costs. You should therefore consider not only the costs of repairs and maintenance, but the additional cost for the appropriate equipment to allow safe access.

Additional defects and repairs could be identified from a closer inspection. It is therefore recommended that a closer inspection be undertaken by a suitably experienced contractor.

You should instruct a reputable contractor experienced in high-level works to quote for repairs to the defects identified in order to ensure you are aware of the potential costs prior to committing to exchanging contracts.

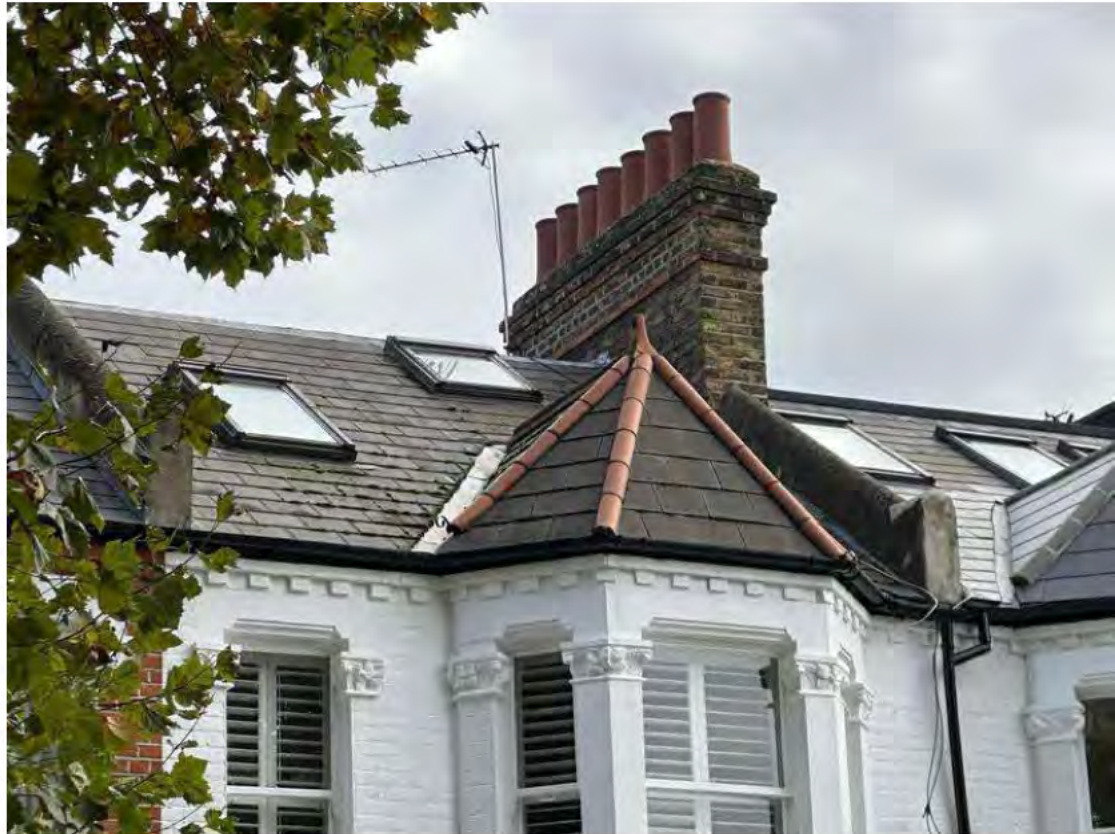
4.2 ROOF COVERINGS

There are a number of damaged slates and the roof is no longer adequately protected from the elements. The roof covering provides protection from the weather to the supporting structure beneath. Where the covering becomes defective, the structure is at more risk of coming in to contact with water which can lead to moisture related issues internally. Condition rating 3

The render to the parapet walls is damaged. The rendered covering is likely to be a cement type that is unsuitable for the type of building. The parapet walls are now at greater risk of deterioration from water ingress which may also penetrate to the inside of the property. Condition rating 2

The masonry to the parapet wall at the rear is deteriorating. The mortar is loose and damaged and bricks are missing. The wall is at risk of further accelerated deterioration due to its condition as rainwater can become trapped within the gaps of the damaged areas. There is also an increased risk of water penetration presenting internally in the future. Condition rating 2

The weatherproofing to the rear dormer is loose. Inadequate water proofing at the junction makes the area more susceptible to water penetration. This can lead to damp issues internally. Condition rating 2

A small selection of the coverings are suffering from a subtle amount of lifting. This happens after installation and mainly affects coverings made from synthetic material. If the defect progresses further the roof may become more susceptible to penetration from driven rain. This can also lead to loosening of the fixings which can lead to the coverings becoming dislodged and slipping. The current degree only appears to affect the appearance and there is no evidence to suggest it is affecting the overall performance of the element. Condition rating 1 A small amount of vegetation is present to the covering and parapet. The presence of vegetation builds up over time and, if left, it can accelerate the deterioration of the affected areas. It should be periodically removed to prolong the lifespan of the roof. Condition rating 1

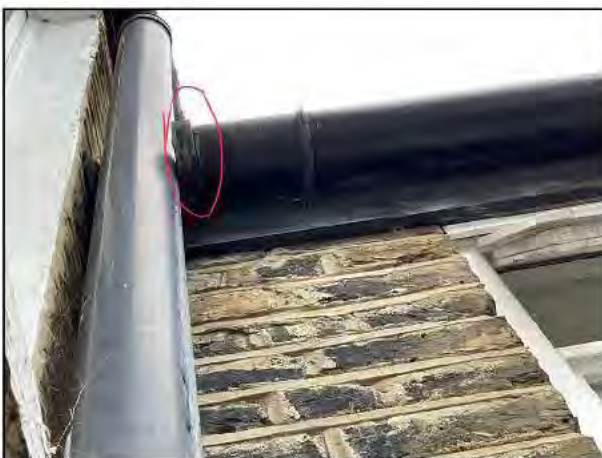
19 - Staining

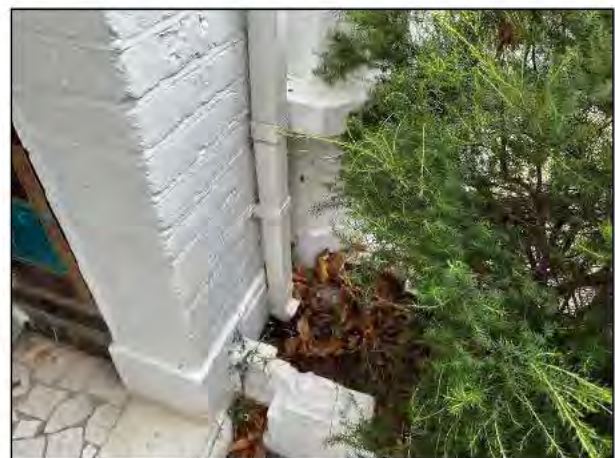
20 - Downpipe

There appear to be sufficient downpipes to allow for the rainwater collected from the roof to drain away effectively. Sufficient downpipes reduces the risk overflowing from the gutters due to backing up of water in heavy rainfall. Condition rating 1

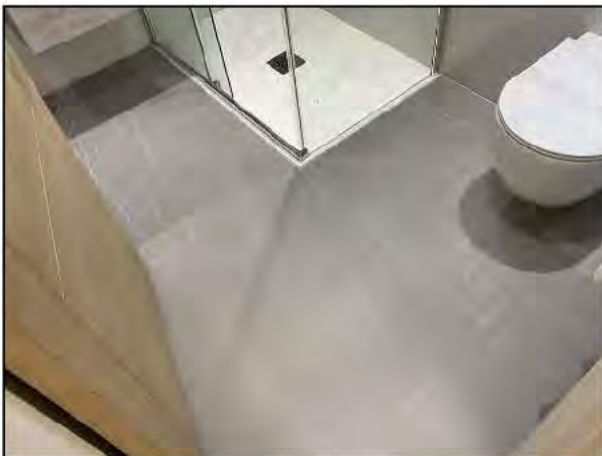
42 - Tiled floor

Solid floors are usually made from concrete and other materials that are supported by the ground. Whilst the solid floor below the coverings could not be inspected, the floor is generally level and there is no sign of any defects. Condition rating 1

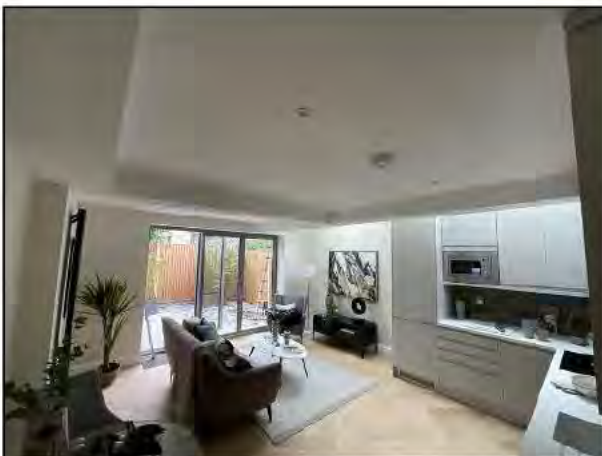
45 - Internal walls removed

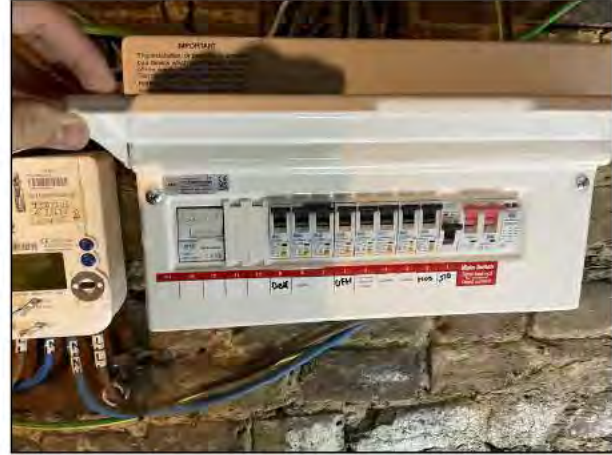
57 - Breakers

Some of the breakers are not protected by an RCD (residual current device). An RCD is a life-saving device that is designed to prevent you from getting a fatal electric shock if you touch something live, such as a bare wire. It can also provide some protection against electrical fires. Condition rating 3

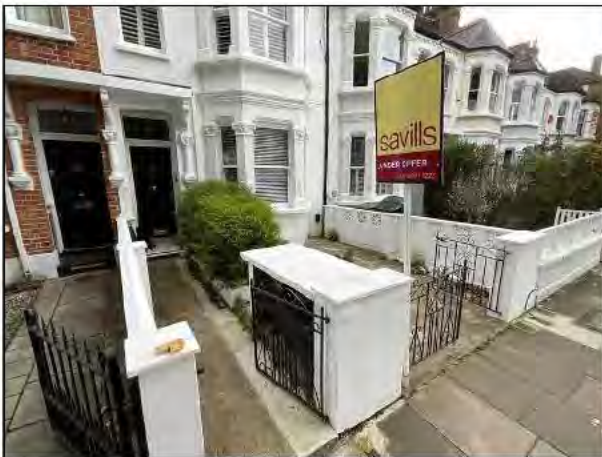
The poured concrete path and block paving in the front garden is deteriorating which is allowing vegetation to grow through the cracks. Exact match repairs are likely to be difficult and you should anticipate that once repaired there will be an obvious difference between the original sections and new sections. Condition rating 2

The marketing details I was provided labelled the front garden as a driveway. A crossover to allow vehicles to access the front garden is not present. This means the front garden cannot legitimately be used for parking a vehicle. There is a cost involved to create the crossover and there is no guarantee that the local authority will approve a future application for a dropped kerb. Condition rating 2

36 - Overview of the front garden

The costs of maintenance to gardens is often overlooked during the property purchasing process. You should instruct a reputable garden contractor to provide you with a quote for the repairing the issues identified before you proceed to exchange contracts.

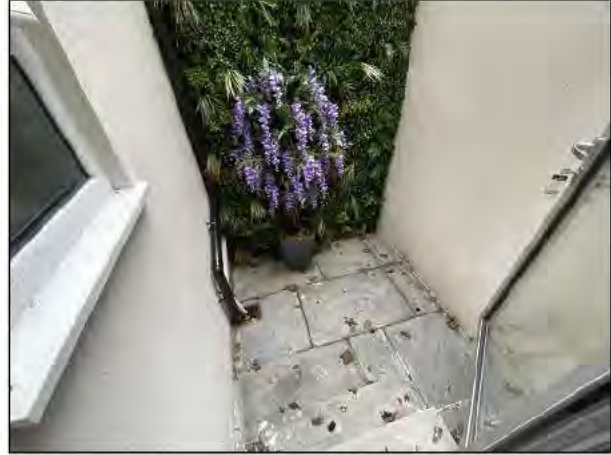
The gardens at the rear are generally well maintained. There are no major defects that are like to result in urgent or costly repairs in order to continue enjoyment of these areas. You must anticipate that regular maintenance will be required in order to keep the gardens in good condition. If not maintained rapid deterioration is likely to occur that may lead to increased future maintenance costs. Condition rating 1

39 - Overview of the rear courtyard garden

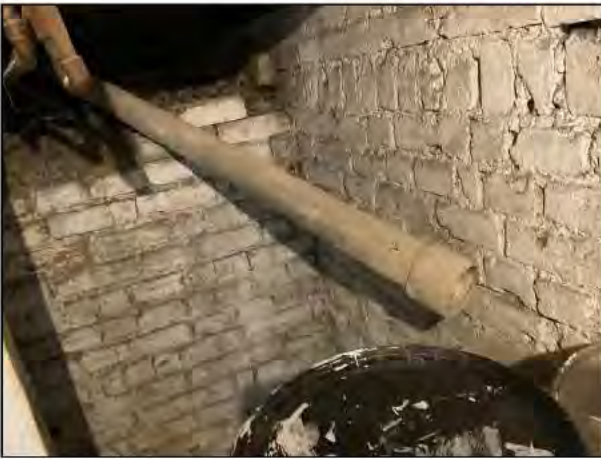
67 - Cement pipe

Although lead pipework was not identified during the inspection. Properties built before 1970 are at risk of containing lead pipework. The risk of lead entering the drinking water can be less severe in hard water areas like London due to the buildup of limescale around the internal pipework creating a coating between the water and metal. For further information and advice, visit the Drinking Water Inspectorate website: www.dwi.gov.uk
